# Post-Occupancy Evaluation of the Wayman Tisdale Specialty Clinic

*April 7, 2013*

## Executive Summary

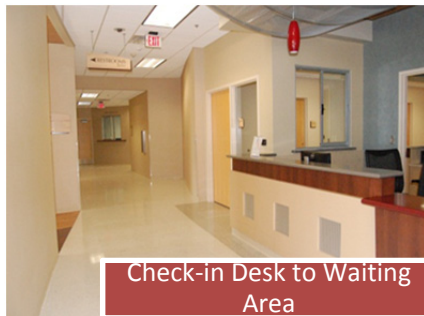
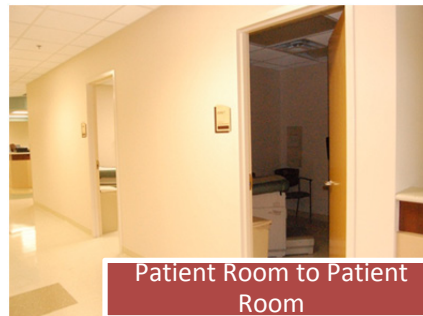
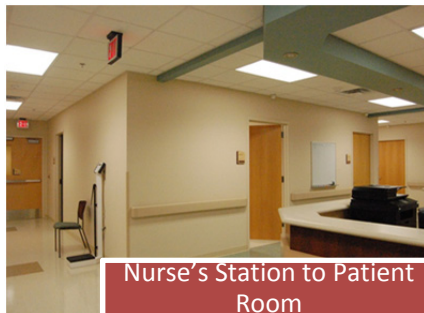
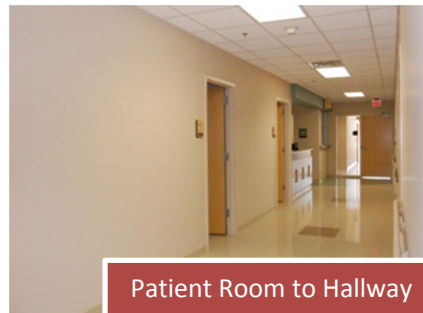
Conversations in examination rooms overheard in another examination room had a poor privacy index. These conversations can clearly be heard and modifications are required to increase privacy.

Maximum Decibel Readings and Decibels Dampened			
Scenario	Source Max	Receiver Max	Decibels Dampened
Check-in Desk to Waiting	74.2	70.5	3.7
Patient Room to Patient Room	81.0	69.2	11.8
Patient Room to Hallway	81.5	68.0	13.5
Nurse's Station to Patient Room	74.8	63.3	11.5

Reroute supply and return air ducts so adjacent examination rooms are not connected to the same line and modify examination room wall height so walls reach to the bottom of the floor above creating a tight seal or alternatively, introduce masking noise or background music to mask sounds from adjacent spaces.

After improvements are complete, repeat acoustic tests to ensure noise levels are reduced and privacy indices improved.

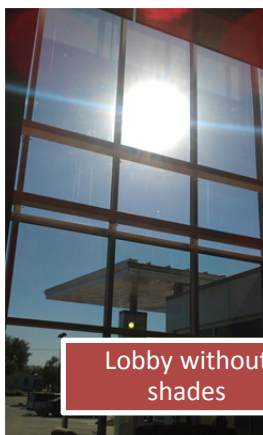
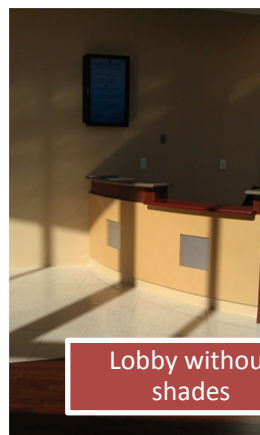
The light levels in the unaltered state ranged from a low of 85 footcandles to a high of 2,149 footcandles with three points over 1,000 footcandles and 10 points under 300 footcandles. Under altered conditions, the light levels were significantly lower ranging from 78 footcandles to 204 footcandles. The recommended illuminance range for the lobby is 2 to 50 footcandles with the higher value only recommended for performing visual tasks of a large size. All readings greatly exceeded the desirable illuminance.

Lobby without shades

Lower the window shades in the afternoons to reduce glare and overall illumination levels.

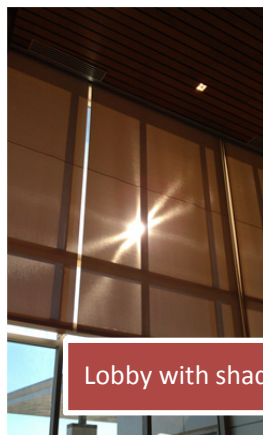
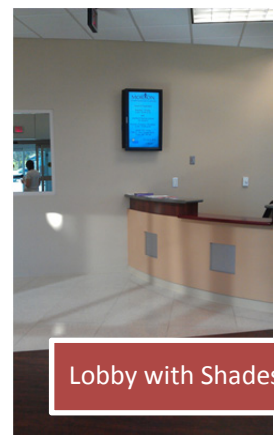
Lobby with shades

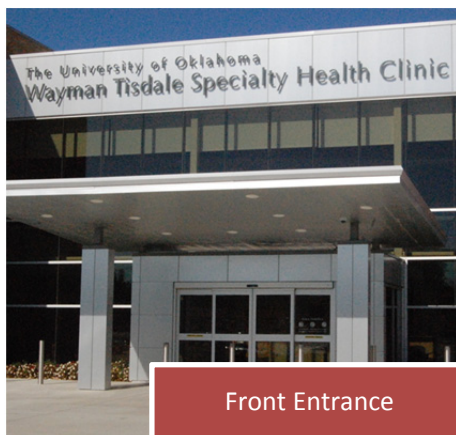
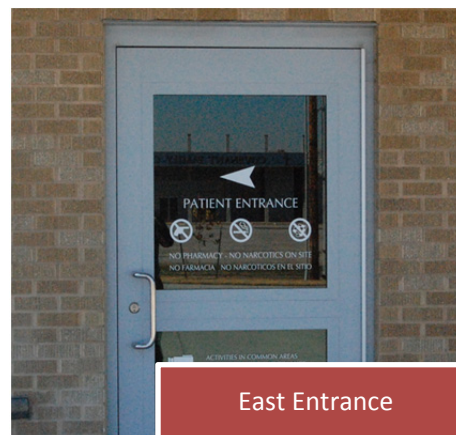
While the main entrance of the building is clearly visible, the side doors on the east side of the building are less legible and only have door decals identifying their purpose, particularly troubling for the ambulance entrance. Protruding signs or canopies should be added to these entrances for clarity especially once they are being used regularly. Directional signage in the parking lots could also be used to direct traffic to the appropriate entrance.

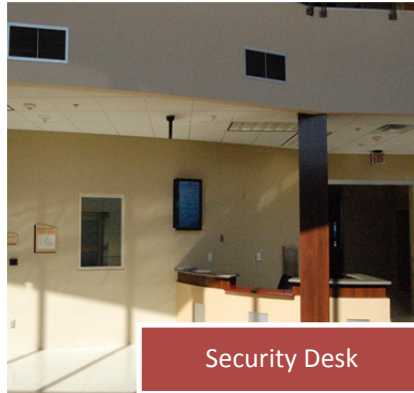
Security Desk

Visitors entering the main lobby may be confused and experience anxiety due to ambiguous architectural cues. Visitors are greeted by an empty reception desk with a suspicious one-way mirror adjacent. The main check-in desk is recessed and to the left. There is no visible means of vertical travel to the second floor and no general directory is provided. The security guard should sit at the front desk instead of behind the one-way mirror. The mirror should be covered by a new general directory.

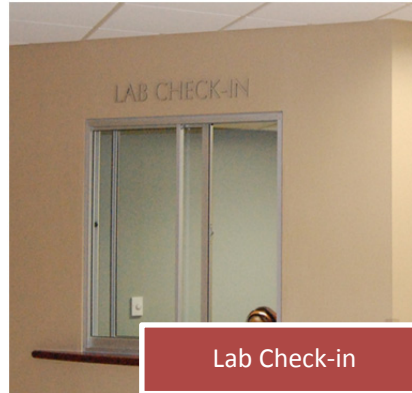
Lab Check-in

The laboratory check-in signage is low contrast and hard to distinguish from the tan color walls. Introduce a high contrast background such as a wood plaque stained to match nearby millwork between the letters and the wall.

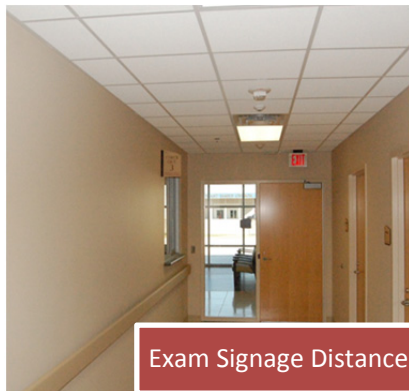
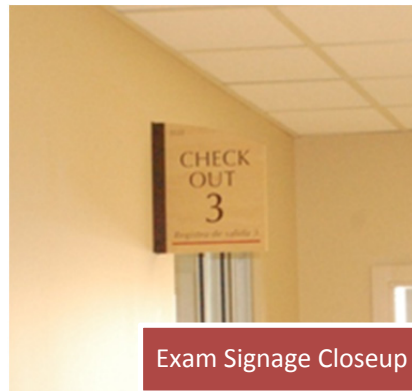
Exam Signage Distance

Exam Signage Closeup

The signs for the checkout areas are small and difficult to see from a distance making it difficult for patients to complete their visit. Replace with larger signs.

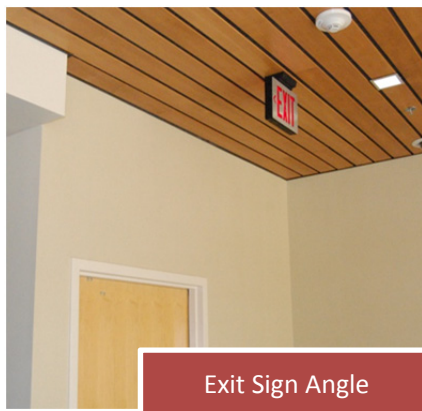
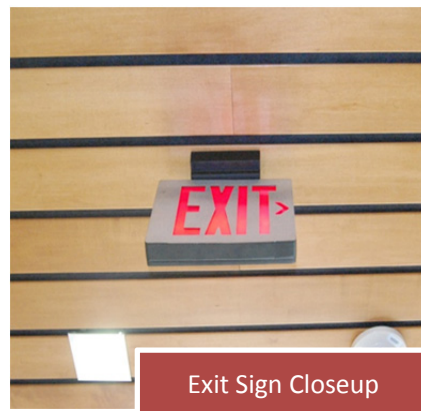
Some exit signs are mounted high on the ceiling and can only be seen at a steep viewing angle. Use extension stems to lower fixtures to better positions.

Exit Sign Angle

Exit Sign Closeup

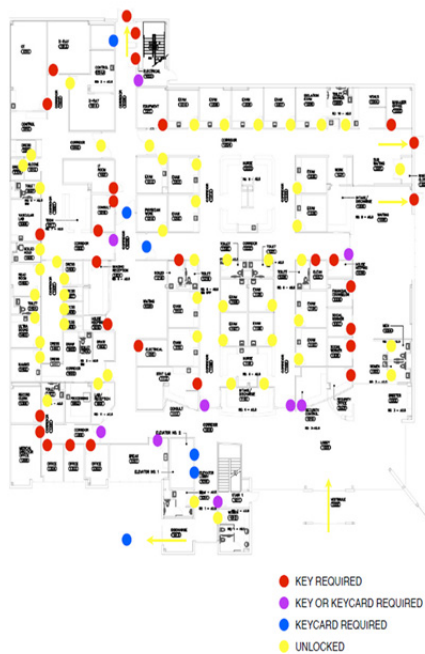
Access Points

Only five doors were unlocked and open to the public, four doors to restrooms and one door to the laboratory and blood draw area. The rest of the doors were adequately secured by key or card key.

The laboratory and blood draw area needs a lock activated by card key or button located at the check-in desk.
