# Pedestrian Plan for Utica Avenue between 3<sup>rd</sup> and 11<sup>th</sup> Street

Anna Grider  
Heloisa Ceccato Mendes

### 4.1. Photo Survey

### 4.2. Windshield and Foot Survey

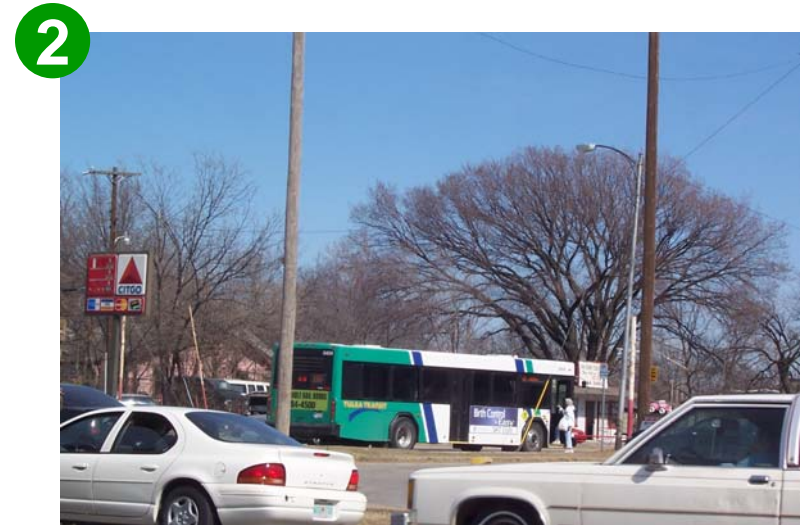
Bus Stop on 3<sup>rd</sup> St. close to the Health Dept: no shelters, no sidewalks

**Bus Stop Improvements** - shelters should be built to protect the passenger from the elements. They should be well-lit for night time use.

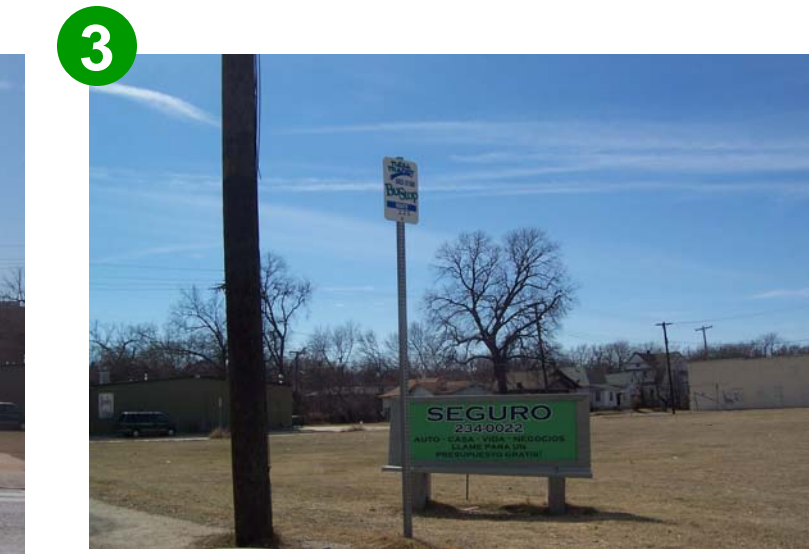
Bus Stop on Utica Ave. & 6<sup>th</sup> St: no shelter, no sidewalk

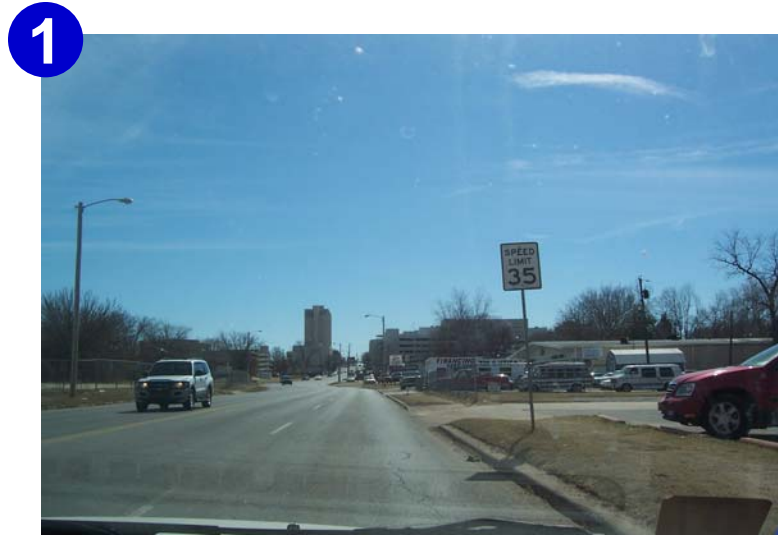
1 No Sidewalks. Sign indicating 35 mph speed limit.

**Infrastructure Upgrades** - the area should have a complete and attractive sidewalk network. This will require street resurfacing and sidewalk infill and repair. Surfaces should be smooth to ensure wheelchairs and strollers can move along easily.

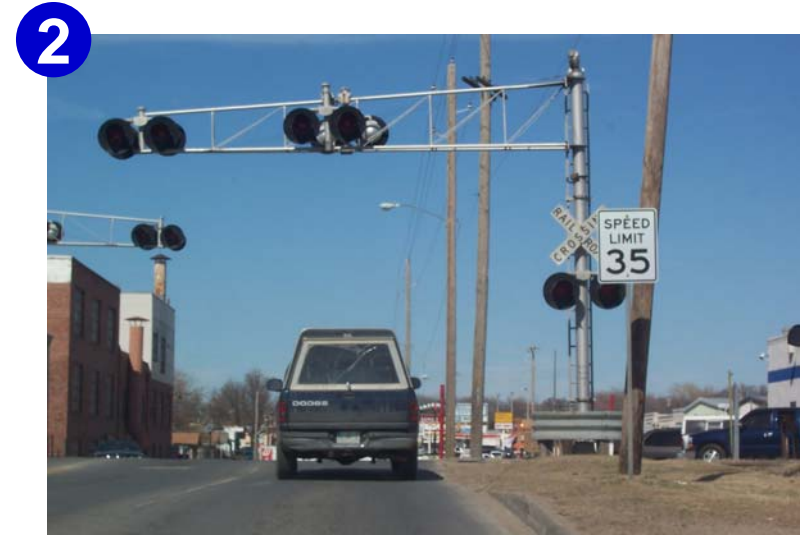
2 No Sidewalks close to the Railroad, a significant barrier for pedestrians.

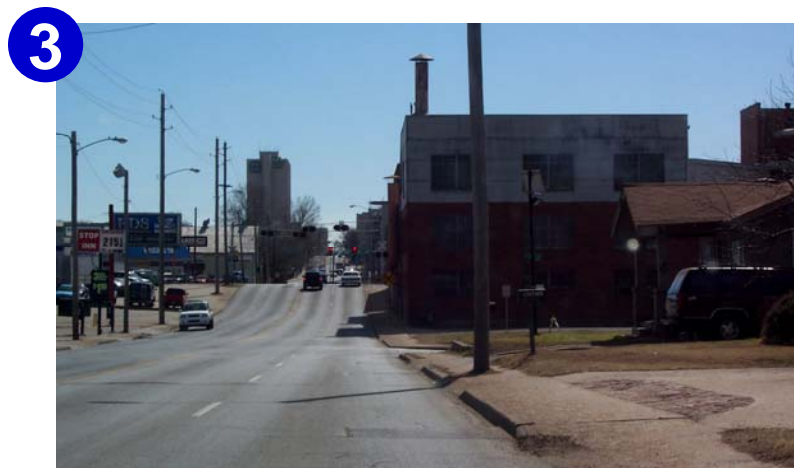
3 Light poles in the middle of the sidewalk create difficulties for the disabled.

**Utility Placement** - policies and standards for utility placement in the pedestrian right-of-way should be reviewed. Although underground utilities reduce the eyesore as well as the inconvenience it is realized that a more cost-effective strategy may be to relocate the poles out of the sidewalk.

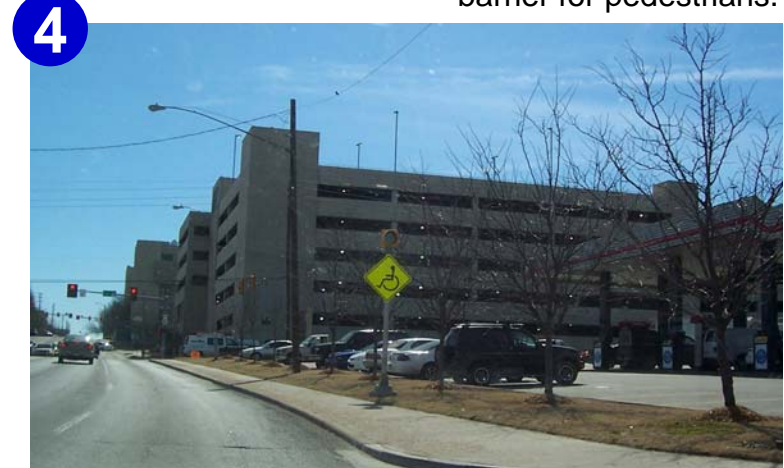
4 Sidewalks close to 11<sup>th</sup> St. and Handicap sign.

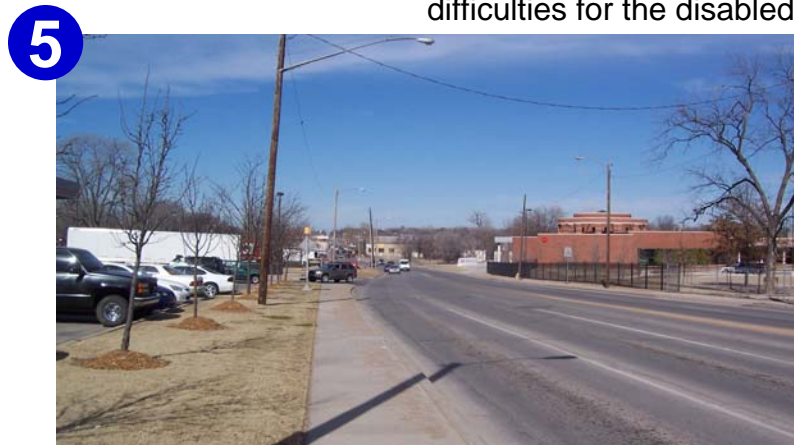
5 Sidewalks on both sides of Utica Ave. close to 11<sup>th</sup> St. intersection. Pedestrian connection between 11<sup>th</sup> Street and The Center for Individuals with Physical Challenges.

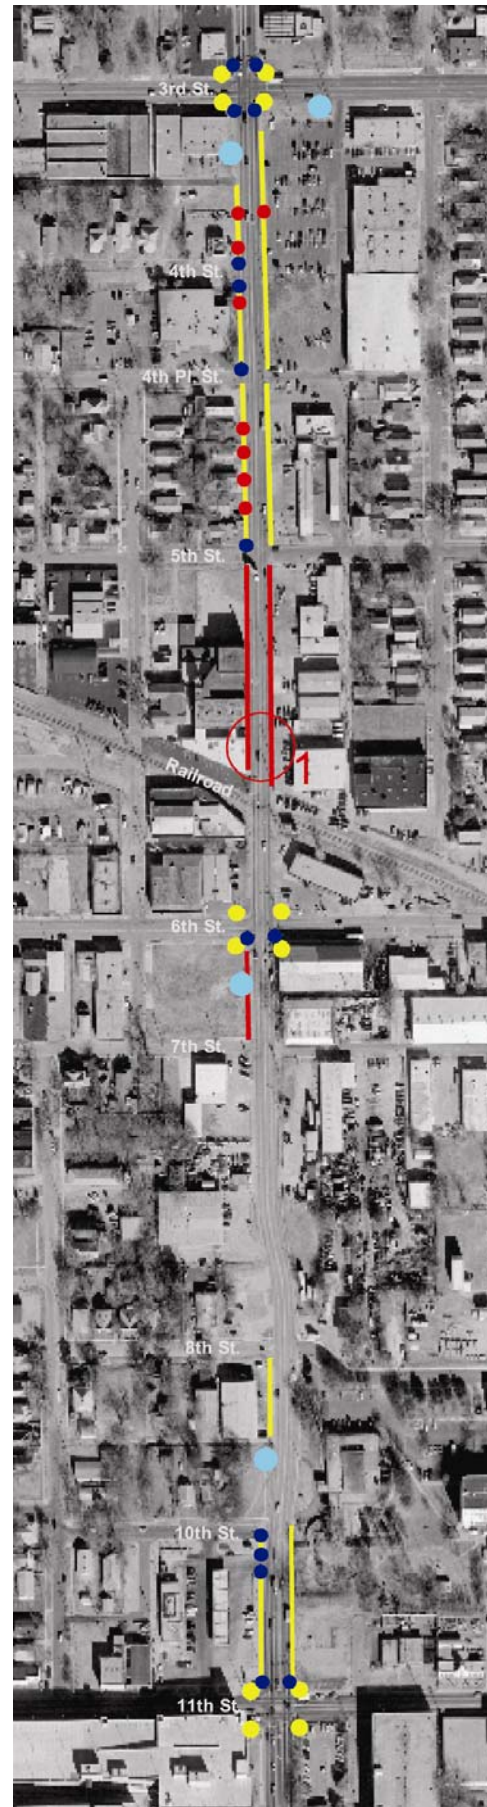
### Existing Conditions

- Bus Stops
- Pedestrian Call Buttons - some not working
- Disabled Access Ramps
- Car Ramps
- Existing Sidewalks - good condition:
- Existing Sidewalks - poor condition:
  1. Steep topography

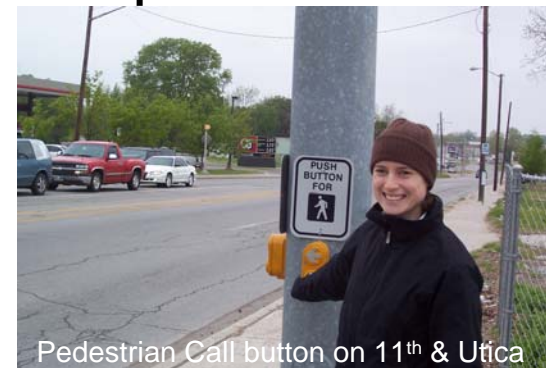
Pedestrian Call button on 11<sup>th</sup> & Utica

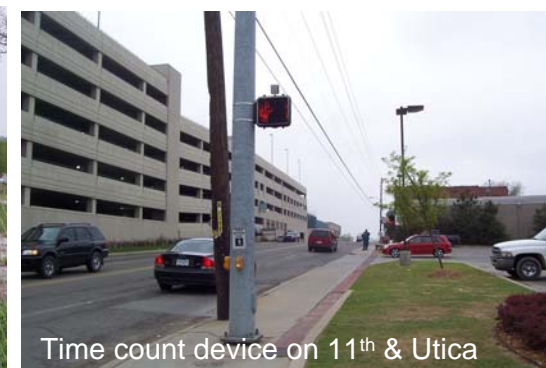
Time count device on 11<sup>th</sup> & Utica

The timing of crossings should be adjusted to allow adequate time for the disabled to cross. The cycling of the lights should be shorter so pedestrians are not waiting a long time for the opportunity to cross. Audible pedestrian signals and a difference in paving could be implemented to assist the visually impaired. At 8th and Utica and 4th and Utica new crosswalks should be placed with pedestrian lights.

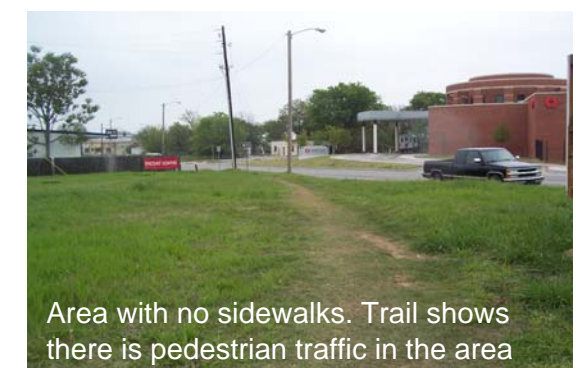
Area with no sidewalks. Trail shows there is pedestrian traffic in the area

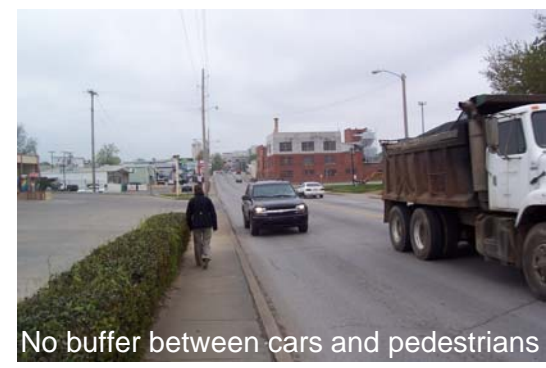
No buffer between cars and pedestrians

**Buffering/Screening** - provide ample buffering throughout the area to protect the pedestrian physically and psychologically from vehicles. This can be in the form of landscaping, trees, planting strips and bollards. Implementation of landscaping can provide shade and other benefits to the pedestrian.

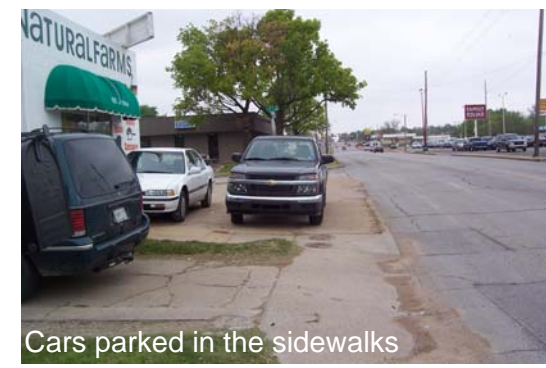
Cars parked in the sidewalks

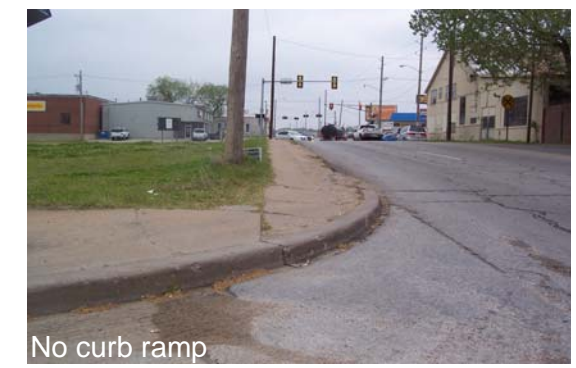
No curb ramp

**Curb Ramps** - should be built or repaired at each crossing location.

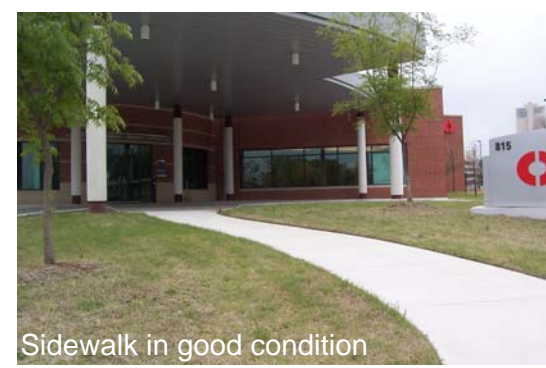
Sidewalk in good condition

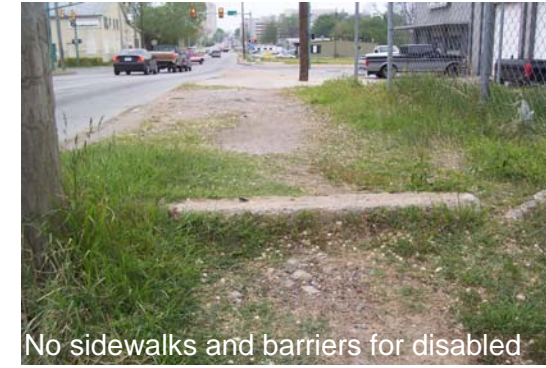
No sidewalks and barriers for disabled

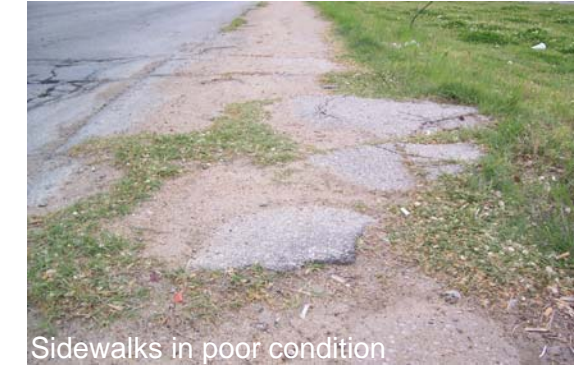
Sidewalks in poor condition

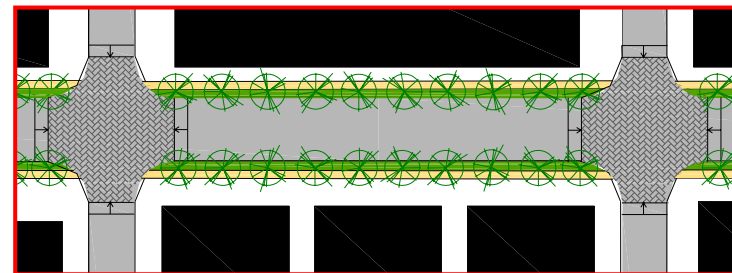
- RECOMMENDED**
- Parking in the rear
  - Buildings close to street:
    - . relationship with the street,
    - . sense of place, enclosure
  - Landscaping:
    - . creates shade for a more pleasant environment
    - . buffering from street / safety for pedestrians
  - Sidewalks
  - Disabled access
  - Elevated Crosswalks:
    - . pedestrian visibility
    - . slow down vehicles

**Building and Zoning Codes** - setbacks should ensure new buildings are built close to the street with parking in the rear or to the side and/or shared parking with other uses. Design guidelines should be implemented to ensure buildings have attractive and interesting facades, wide and abundant windows and pedestrian-oriented entrances. Zoning should encourage active uses like retail or restaurants (see schemes opposite).

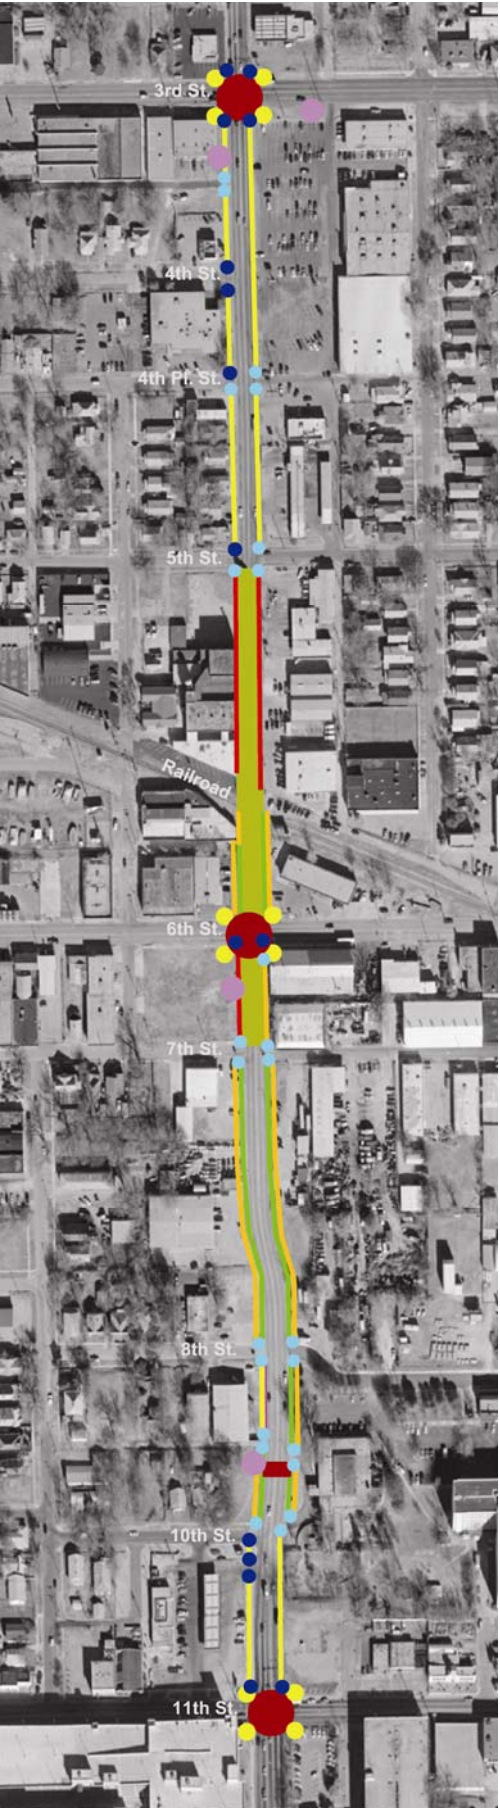
### Proposal

- Bus Stops Shelters
- Pedestrian Call Buttons - maintenance
- Raised Intersections
- Crosswalk and Pedestrian Light
- Textured Pavement
- Existing Sidewalks - in good condition
- Enhance existing Sidewalks
- New Sidewalks
- Landscaping
- Bollards
- Proposed Curb Ramps for Disabled Access
- Improve Existing Curb Ramps for Disabled Access

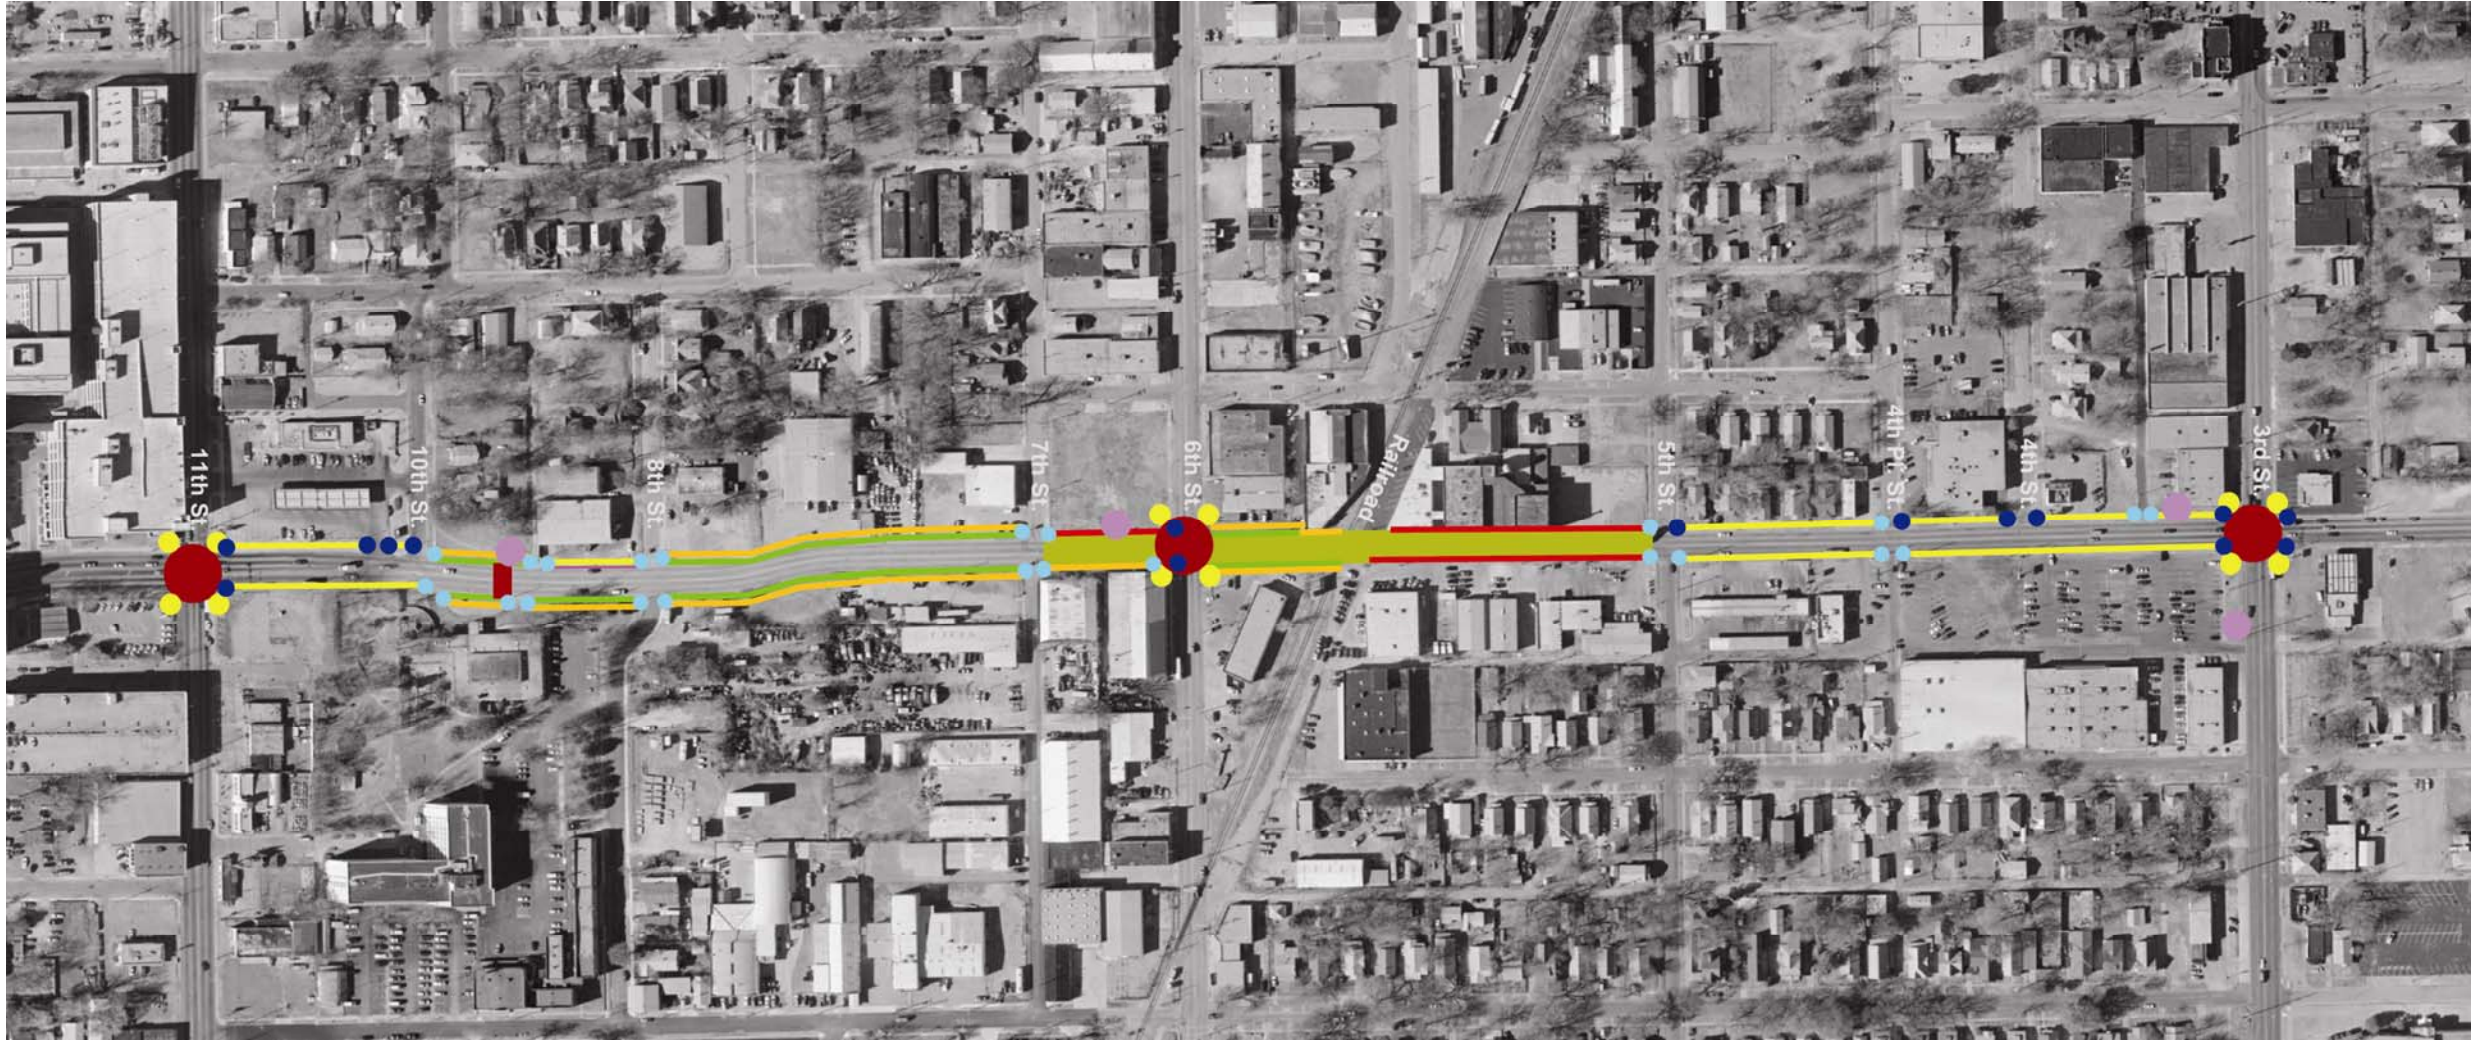
### Proposal

- Bus Stops Shelters
- Pedestrian Call Buttons - maintenance
- Raised Intersections
- Crosswalk and Pedestrian Light
- Textured Pavement
- Existing Sidewalks - in good condition
- Enhance existing Sidewalks
- New Sidewalks
- Landscaping
- Bollards
- Proposed Curb Ramps for Disabled Access
- Existing Curb Ramps for Disabled Access
