# Post-Occupancy Evaluation of the Wayman Tisdale Specialty Clinic

*April 7, 2013*

## Executive Summary

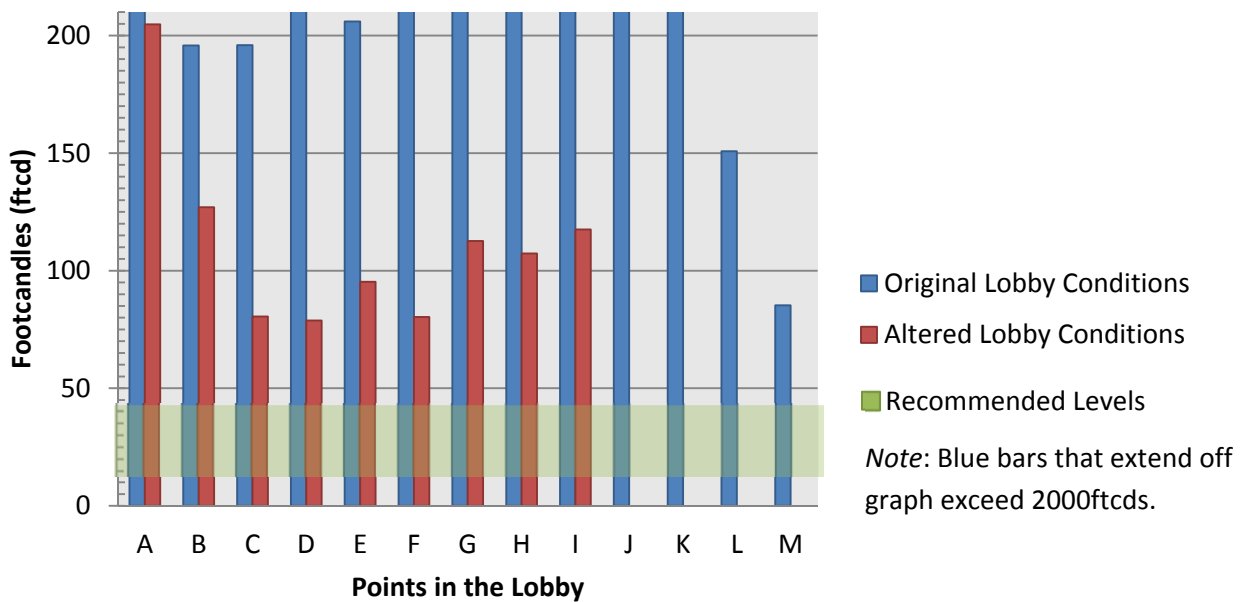
**Light Levels in the Clinic Lobby (from 0-230 ftcd)**

The light levels in the unaltered state ranged from a low of 85 footcandles to a high of 2,149 footcandles with three points over 1,000 footcandles and 10 points under 300 footcandles. Under altered conditions, the light levels were significantly lower ranging from 78 footcandles to 204 footcandles. The recommended illuminance range for the lobby is 2 to 50 footcandles with the higher value only recommended for performing visual tasks of a large size. All readings greatly exceeded the desirable illuminance.

Adjust the lighting controls in the lobby to turn off the overhead lights during the day unless light levels drop below 20 footcandles. A manual control for overriding the automated controls is also desirable for user controls.
